James J Kilroy
1701 Enterprise Dr, Canton, Ohio

Inspection date
September 04, 2018

Level of inspection
Level II

Masonry Chimney damaged by lightning

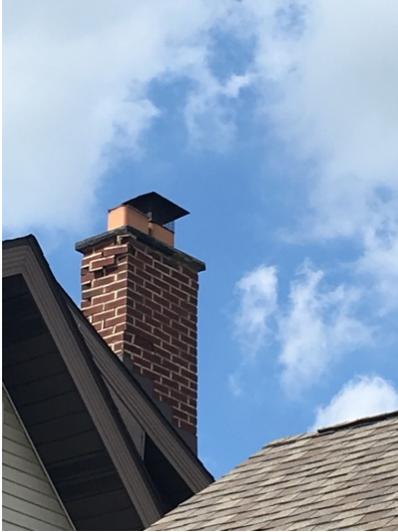
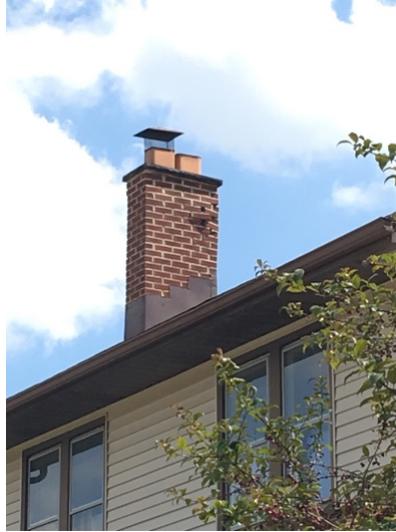
This chimney was struck by lightning. Claim # 5555555 John Schmidt 419-306-XXXX

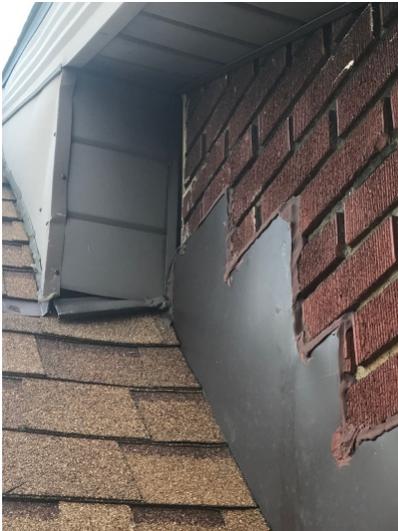
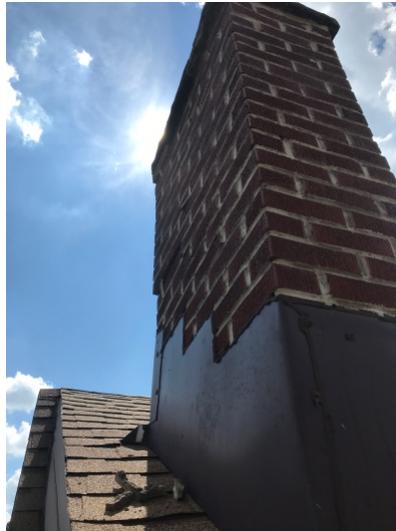
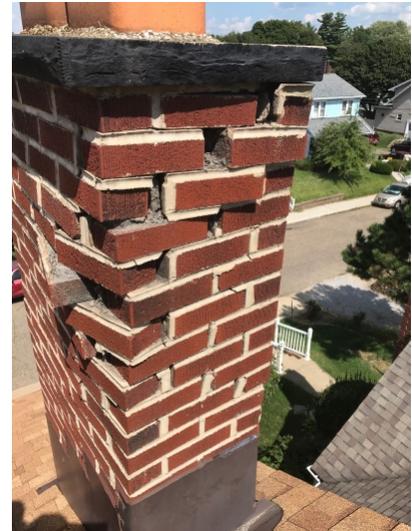
The bricks are no longer being held in place by the mortar. The chimney needs to be taken down to the lower roof and rebuilt

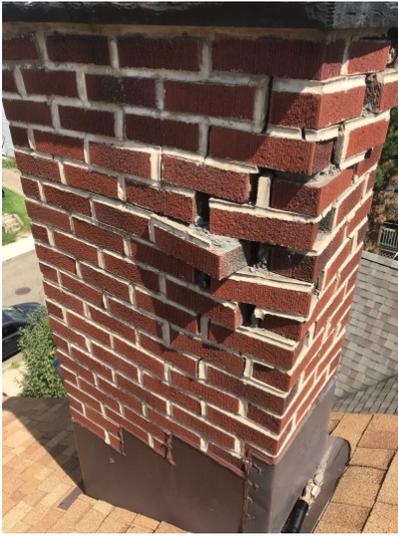
The force of the lightning strike has dislodged much o

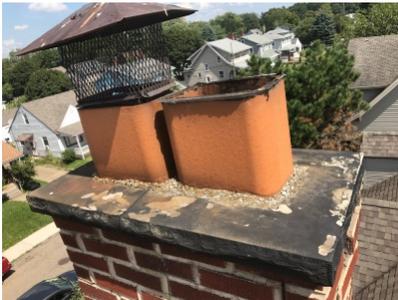
The stone crown of the chimney is attached to the tile with mortar. It will not likely be reusable when removed

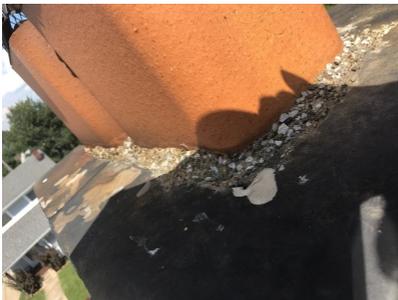
Heating and cooling of the flue tile can cause the tile to expand and contract. This expansion of the flue tile can cause the tile length to increase. The flue tile needs to be able to move through the crown/ wash cap of the chimney to help prevent damage to the tile the chimney, or the crown / wash cap. This is done by an expansion joint that prevents the masonry material from bonding with the flue liner and preventing this movement. This joint must be sealed in a way that does not allow moisture to enter the chimney. Industry standard IRC 2103.12 2016 NFPA 211 7.2.13.4

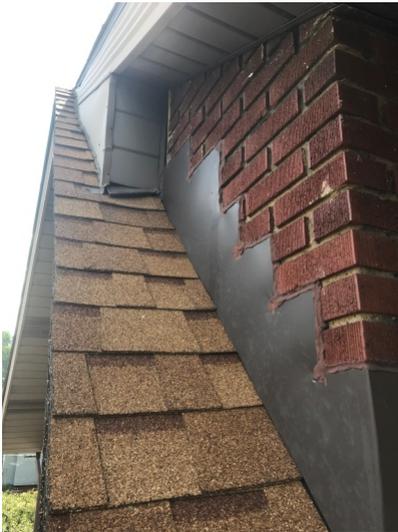
The flashing will need replaced after it is removed to allow for the chimney rebuild

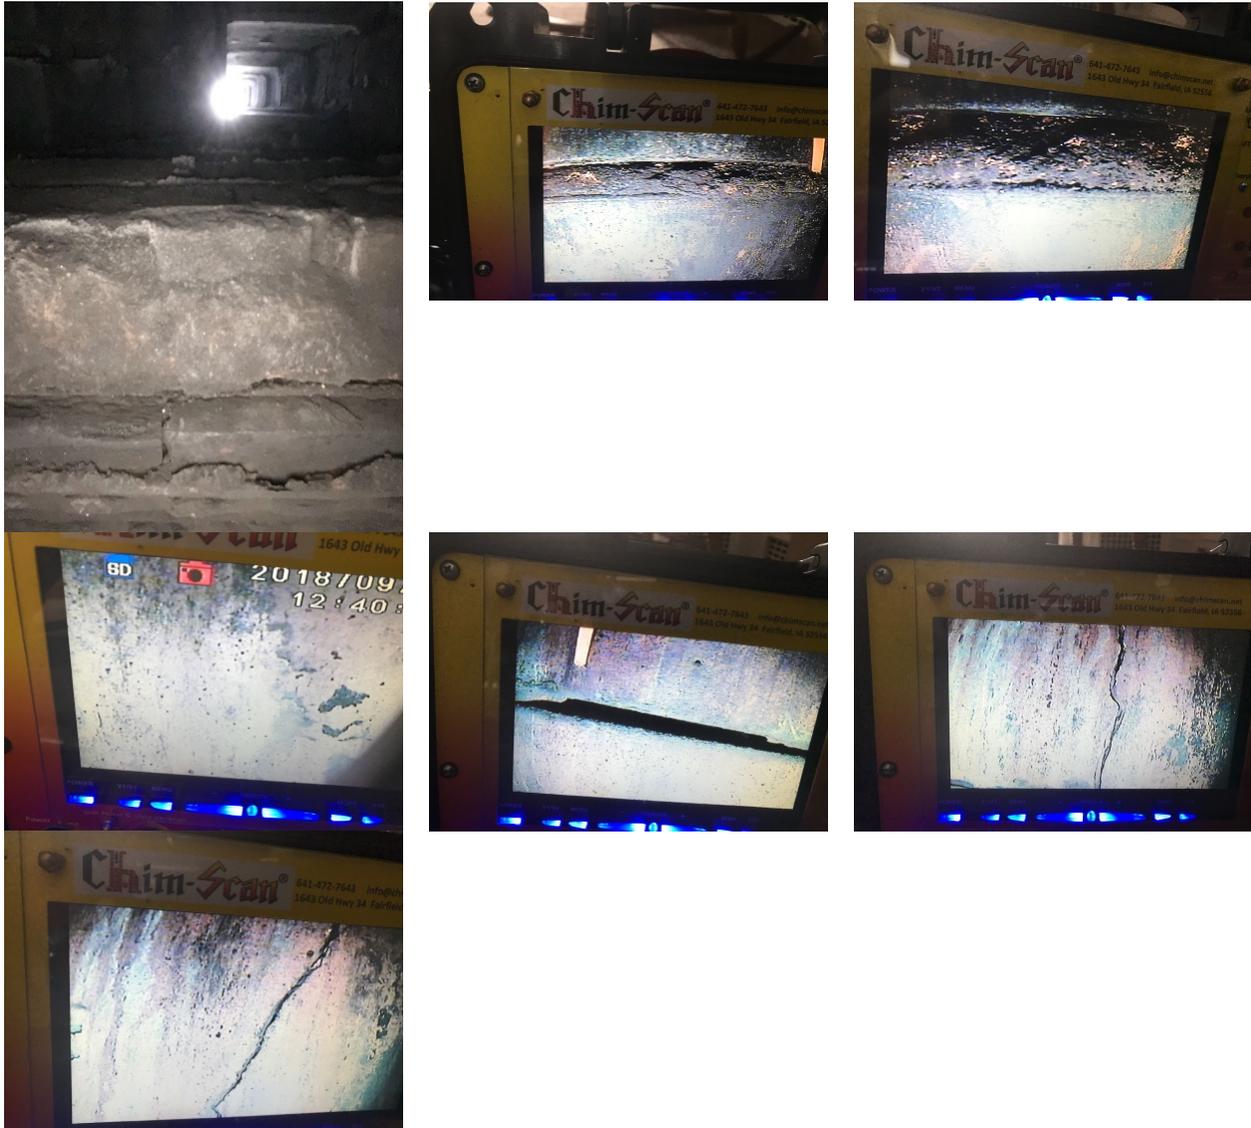
The lightning strike caused the surface of the tile to “pop” in a way that resembles flaking or spalling of the tile. This flue system is no longer capable of containing the by

There is spalling or flaking of the tile. This is evidence that the tile is softened or derogated to a point where it can no longer perform its intended function of containing all of the byproducts of combustion and transferring them to the outside. This flue must be repaired if possible or a new lining system installed 2016 NFPA 211 14.9

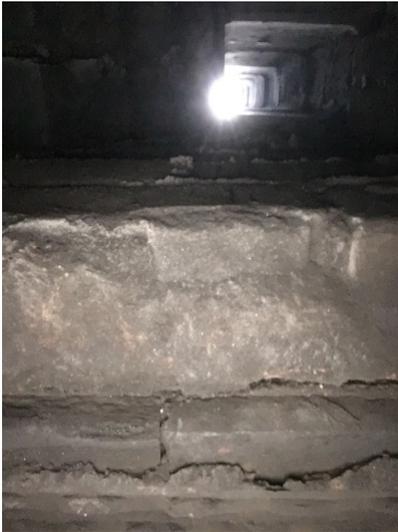
The smoke chamber walls are not parged smooth. This can cause a chimney to draft poorly. Lack of the parging material may also increase the risk of a structural fire and the risk of the byproducts of combustion migrating into the home. 2016 NFPA 211 11.2.1.13 IRC 2006 2111.S

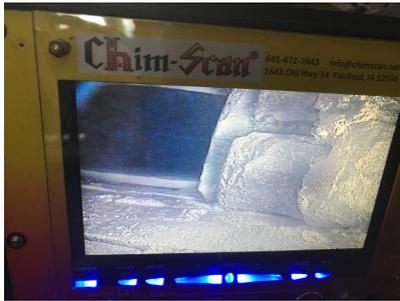
The tile is not sealed at the top of the smoke chamber

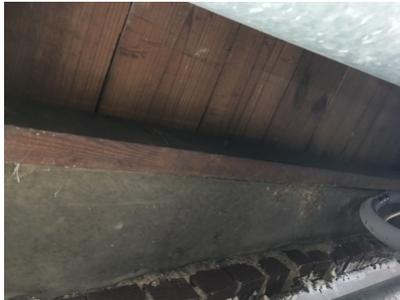
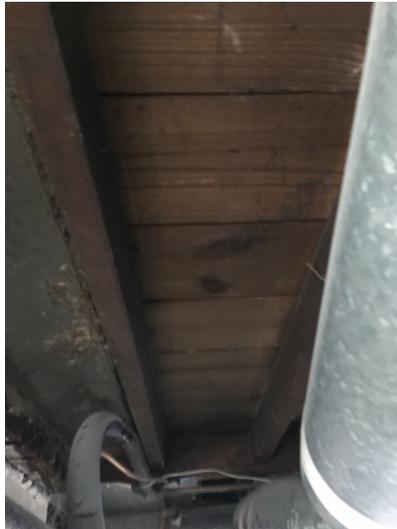
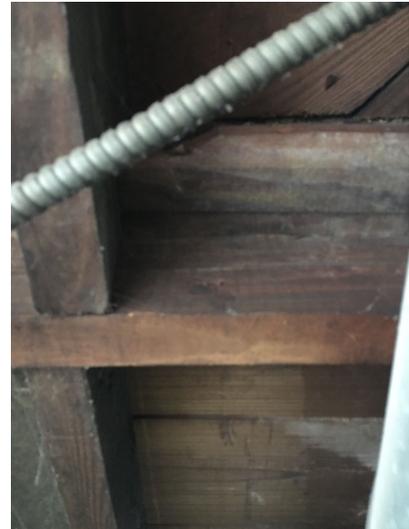
Masonry is a great conductor of heat. Heat can be transferred through the hearth and hearth extension under the fireplace. If there is wood in this area it will get dryer over time (this process is known as pyrolysis) and be more easily ignited as the wood gets older. These supports were required to be removed at the time of construction. 2016 NFPA 211 11.3.1.2 IRC 2006 2111.9

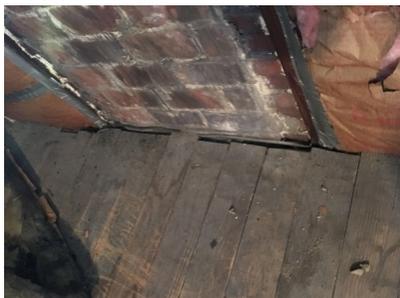
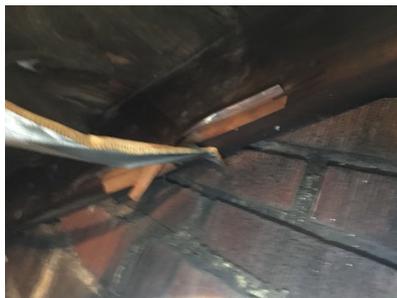
There is combustible framing touching the chimney in the attic space.
2018 I.R.C. R1003.18 Chimney clearances. Any portion of a masonry chimney located in the interior of the building or within the exterior wall of the building shall have a minimum airspace clearance to combustibles of 2 inches (51 mm). Chimneys located entirely outside the exterior walls of the building, including chimneys that pass through the soffit or cornice, shall have a minimum airspace clearance of 1 inch (25 mm). The airspace shall not be filled, except to provide fire blocking in accordance with Section R1003.19.

There is a cloth coated wire in contact with the chimney. This is a potential hazard

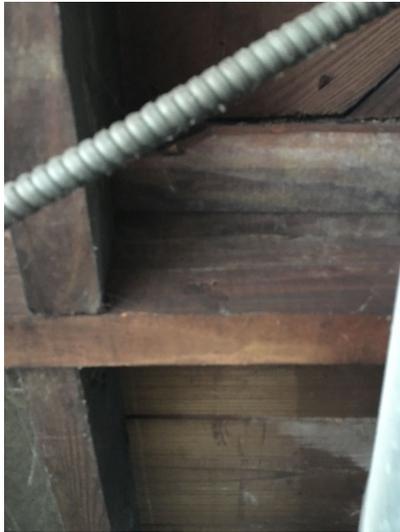
There are combustible materials that are within the 4" required clearance below the hearth extension. This presents a possible fire hazard. The masonry hearth extension can conduct heat that could allow the combustible materials to dry out and have a lowered ignition temperature over a period of time. The potential exists for these combustibles to ignite. Industry standard 2016 NFPA 211 11.3.1

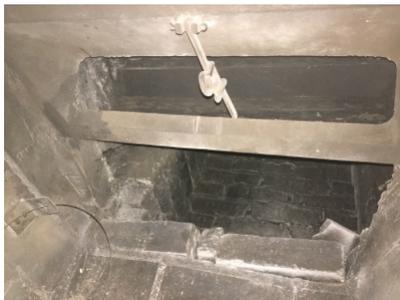
The firebox was blown out by the lightning strike. Bricks were laying on the grate after the strike

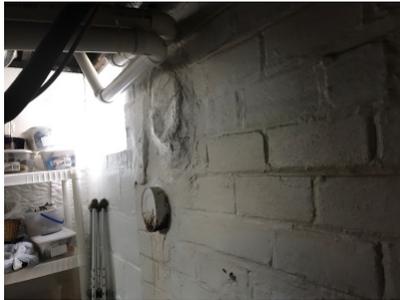
The clean out cap is deteriorated.

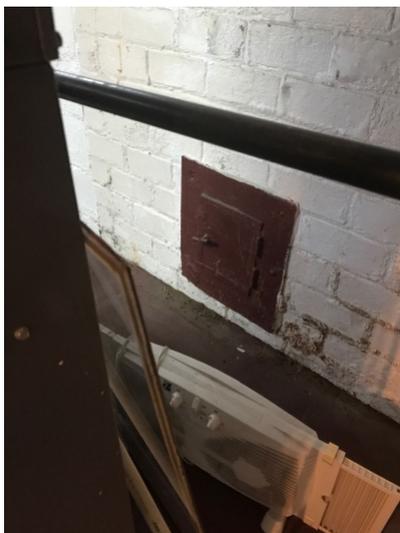
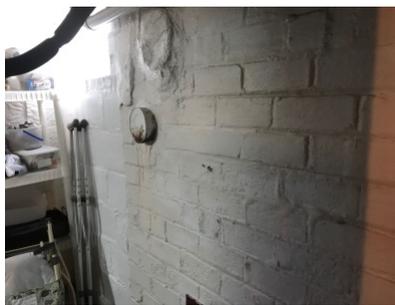
The clean out door is not in good repair and should be replaced 2016 NFPA 211 7.1.4.1
